# PARTITION PLAT NO. 2018-109

BEING A REPLAT OF PARCEL 1 OF  
PARTITION PLAT 2015-083 IN THE  
NE1/4 AND SE1/4 SECTION 11,  
NW1/4 AND SW1/4  
SECTION 12, T.3S., R.1W.,  
WILLAMETTE MERIDIAN  
CITY OF WILSONVILLE,  
CLACKAMAS COUNTY, OREGON

Parkway Woods  
Wilsonville, Oregon

ENVIRONMENTAL AREAS  
PRELIMINARY IMPROVEMENT PLANS  
PARKWAY WOODS INDUSTRIAL PARK  
WILSONVILLE, OREGON

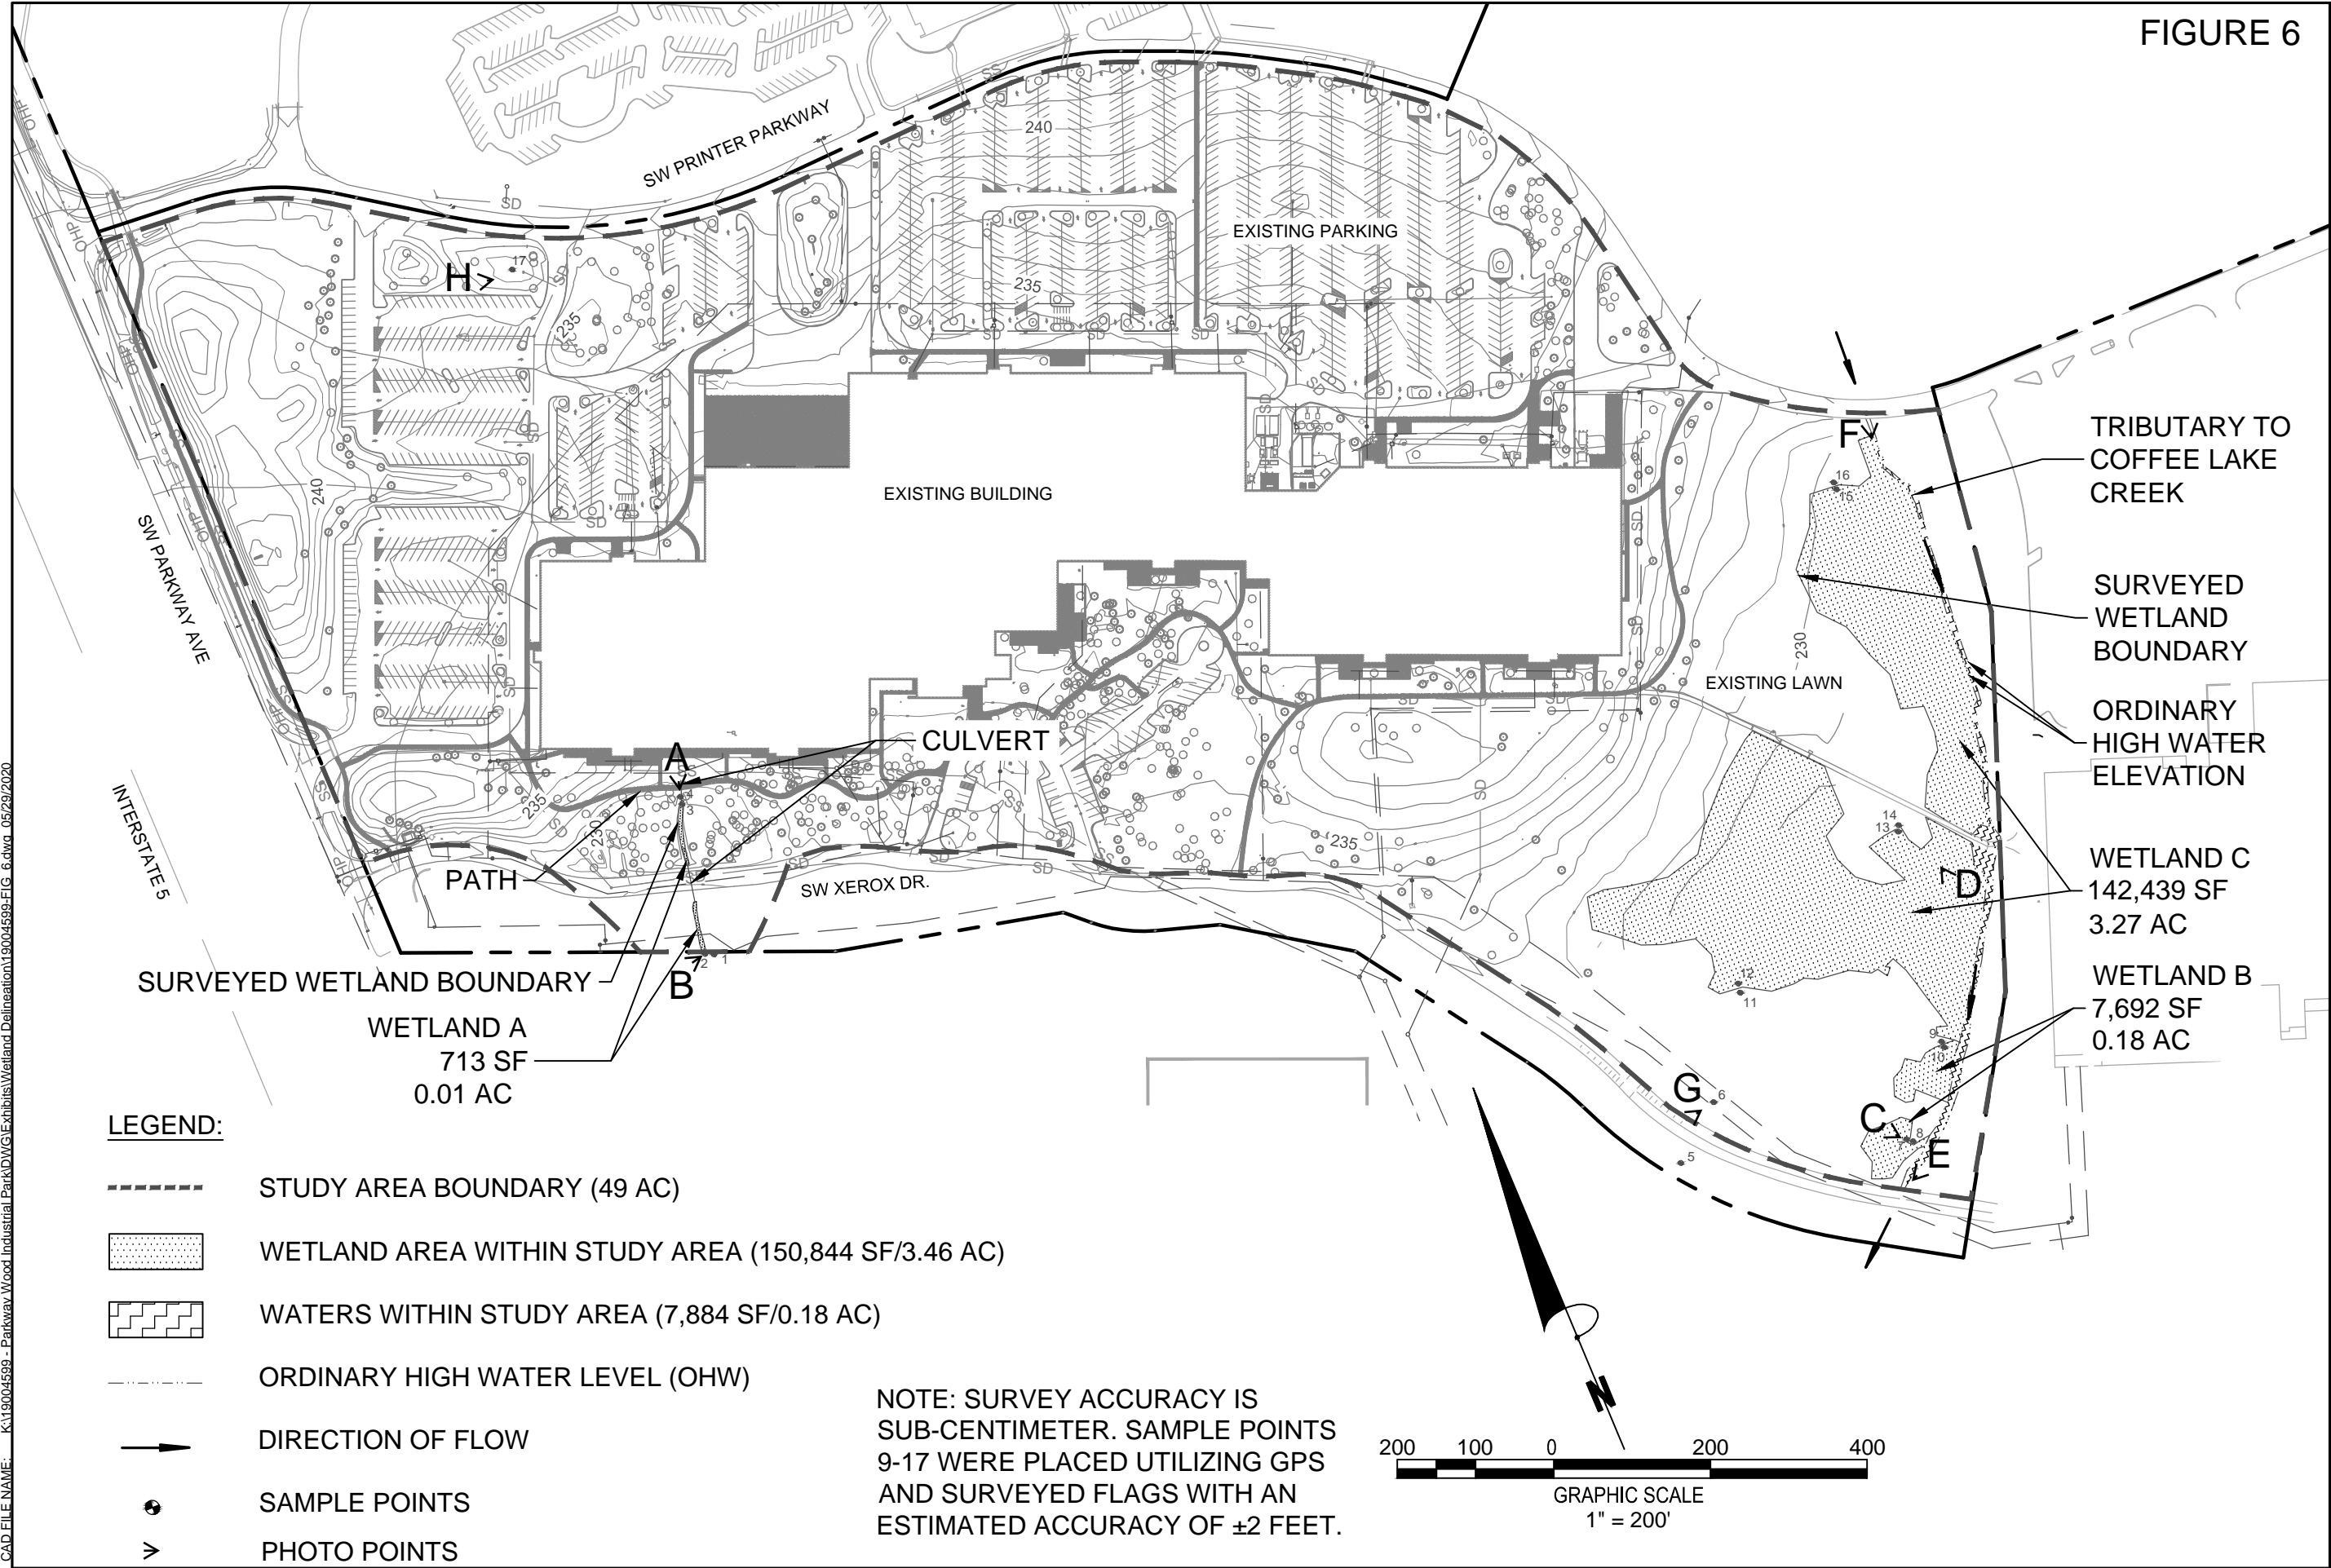
FIGURE 6

NOTE: SURVEY ACCURACY IS SUB-CENTIMETER. SAMPLE POINTS 9-17 WERE PLACED UTILIZING GPS AND SURVEYED FLAGS WITH AN ESTIMATED ACCURACY OF ±2 FEET.

PARKWAY WOODS BUSINESS PARK  
WILSONVILLE, OREGON  
**EXISTING CONDITIONS**

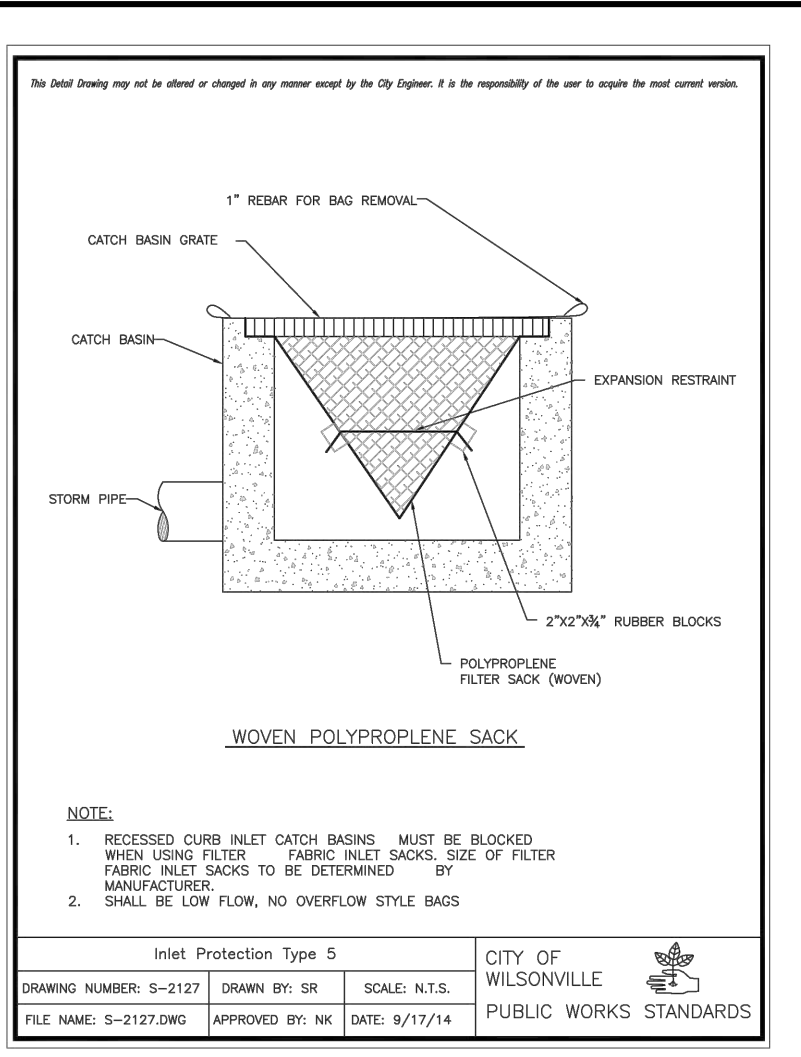
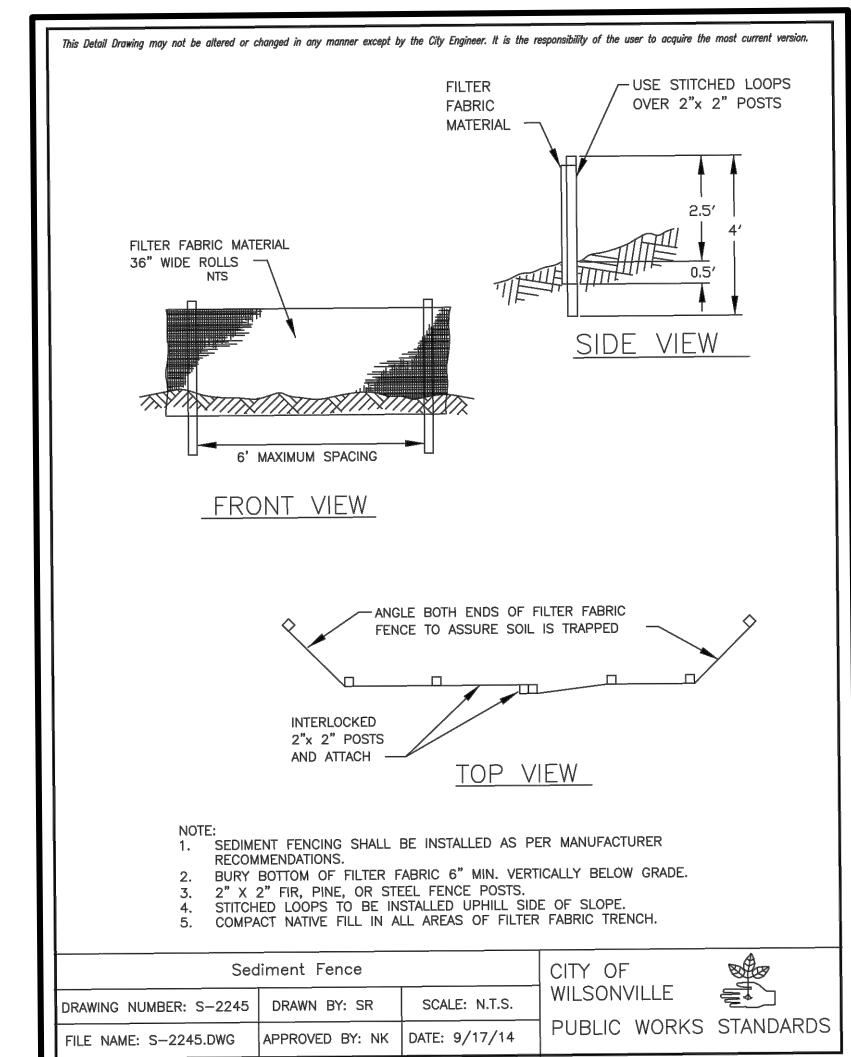
- DO NOT REMOVE TEMPORARY SEDIMENT CONTROL PRACTICES UNTIL PERMANENT VEGETATION OR OTHER COVER OF EXPOSED AREAS IS ESTABLISHED. ONCE CONSTRUCTION IS COMPLETE AND THE SITE IS STABILIZED, ALL TEMPORARY EROSION CONTROLS AND RETAINED SOILS MUST BE REMOVED AND DISPOSED OF PROPERLY, UNLESS DOING SO CONFLICTS WITH LOCAL REQUIREMENTS. (SCHEDULE A.8.C.III.(1) AND D.3.C.II AND III)

PARKWAY WOODS BUSINESS PARK  
WILSONVILLE, OREGON  
EROSION/SEDIMENT CONTROL DETAILS

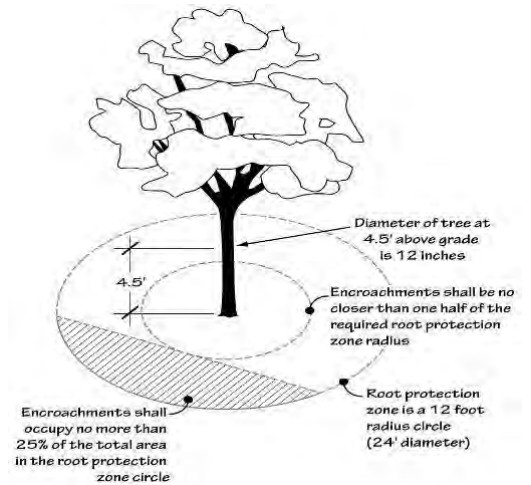
Figure 1: Typical minimum protection zone
